# Study on Conservation and Succession of Village Landscape of Sasabuki,

## A case of Kamiseya area, Miyadu City, Kyoto Prefecture

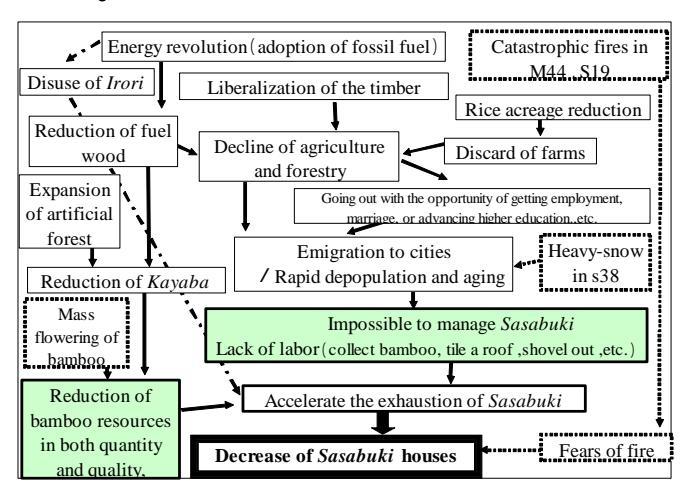
#### Fig.1: Factors of diminution in the number of Sasabuki

In Kamiseya, management of Sasabuki houses was previously supported by Temagashi (a system of mutual assistance). The changing process of the village landscape is divided into 4 parts, according to the increase and decrease of Sasabuki and the changes in social conditions. From 1960 to 1970, Sasabuki houses dramatically decreased. The causes were a lack of labor due to rapid depopulation and aging, and a reduction of bamboo resources in both quantity and quality, because Kayaba (places suitable for bamboo growth, such as after cutting fuel wood) had narrowed and had been replaced by artificial forests. I estimated main resources and labor requirements in order to repair half of a Sasabuki roof common size in Kamiseya. These resources and requirements were 1000 bundles of bamboo (about 1ha in calculated area), 40 reapers (25 bundles per reaper). Of those surveyed, the householder's personal attachment to Sasabuki as well as the existence of craftsmen and bamboo-reapers close to them have allowed for the maintenance of Sasabuki. In the case of Miyama Town, conservation activities which were carried out by local residents in order to preserve the thatched village were connected with support from the government, and as a result, the succession of the village landscape has brought local-activation. While learning from these cases, it is significant to devise a system which manages and utilizes Sasabuki in order to allow the succession of Sasabuki village landscape.
